Bosworth Creek Water Quality
Data Study:

Final Report

Collins, L.A., C.D. Murray and R.T. Stainton. 2011.
Bosworth Creek Water Quality Data Study: Final Report
Environmental Studies Research Funds Report No. 185. Oshawa, ON. 69 p.

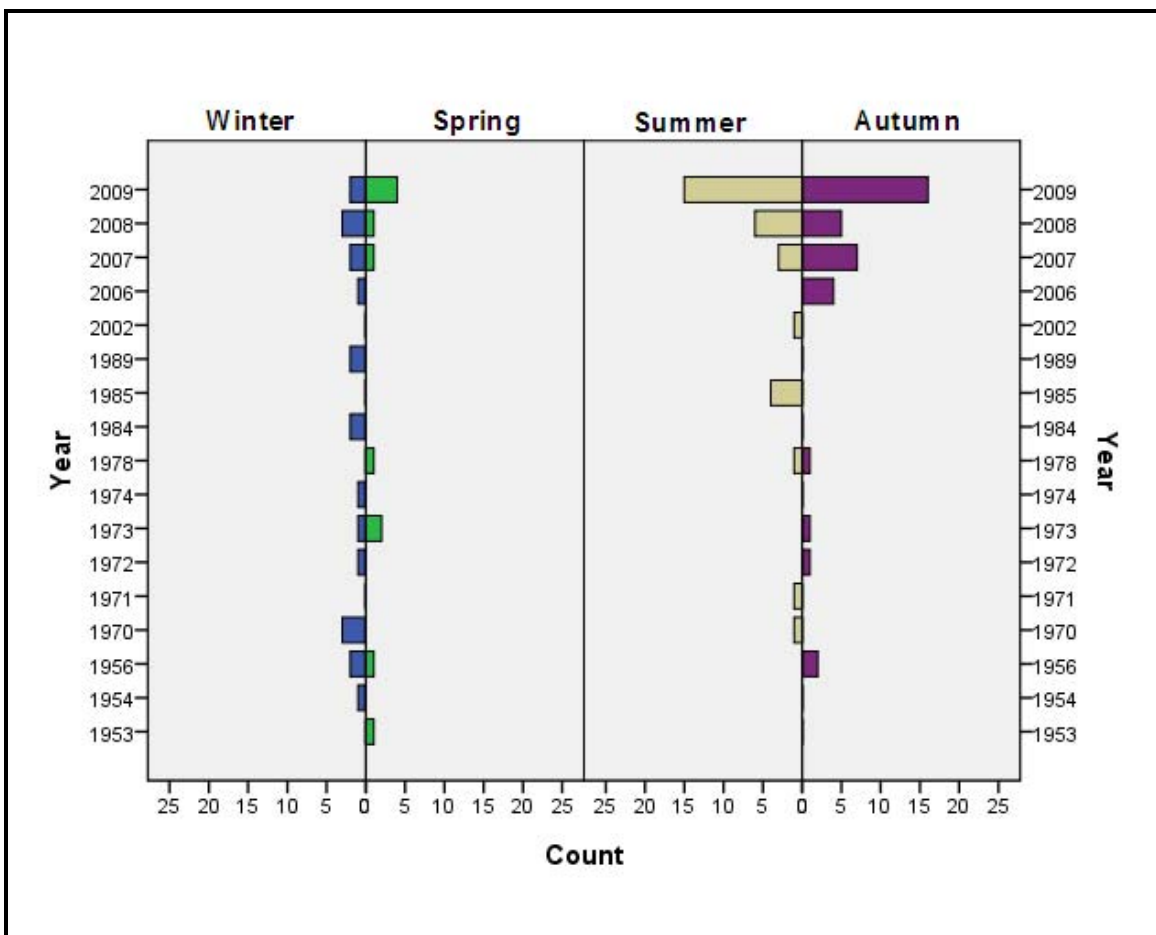
Figure 4. Distribution (count) of samples by season throughout the period of record (1953-2009), independent of sample site location

The distribution of data by season through the period of record, independent of site affiliation, is shown in Figure 4. Overall, considerably more samples were collected in the summer and fall than for the other two seasons, as shown in Figure 4. More samples were also collected in recent years relative to past years (Figure 4). Overall, Figure 4 emphasizes the inconsistency in sampling to be representative of all four seasons throughout the period of record, but shows the benefit of increased sampling densities for the period 2007 to 2009.

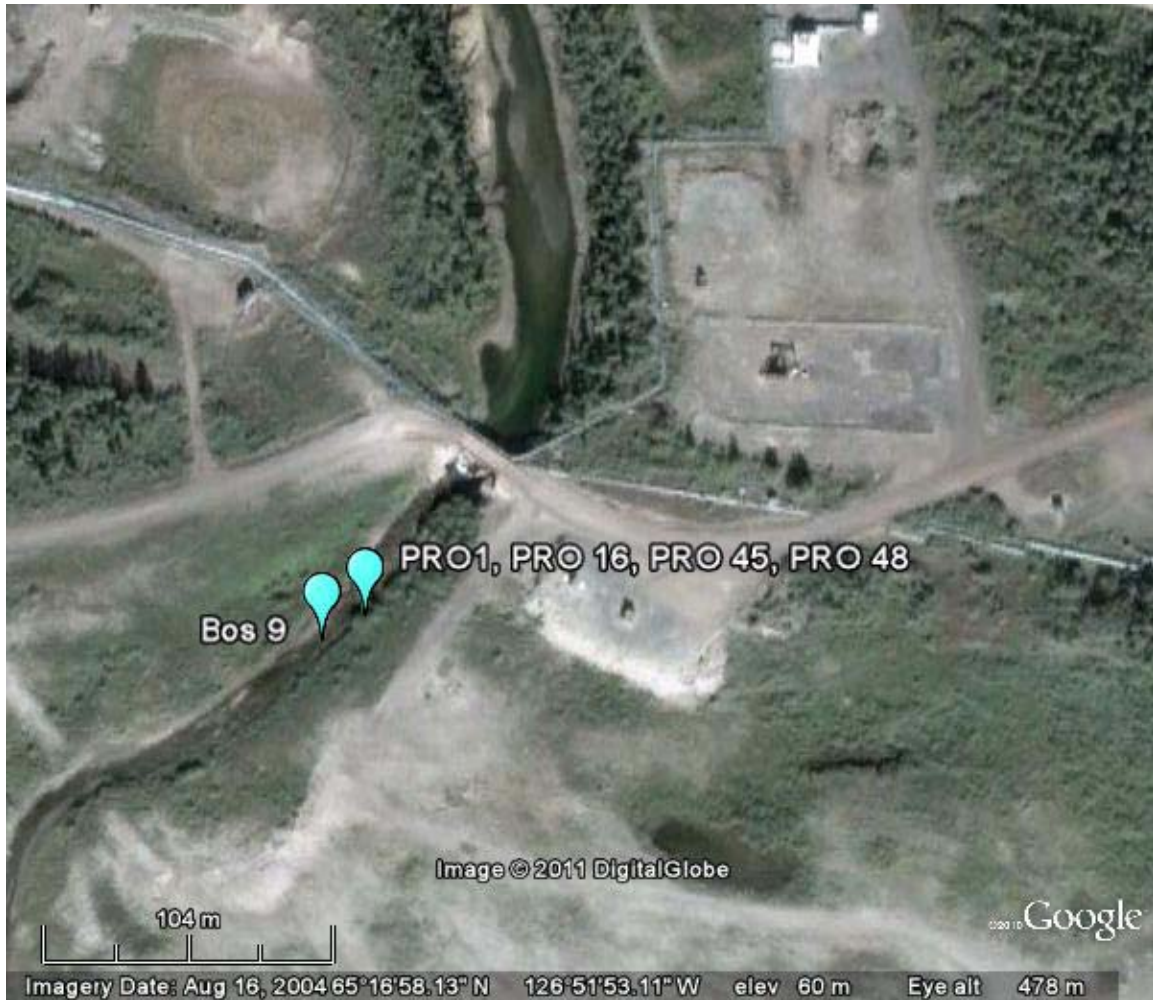
Figure 24. Lower Bridge South site sample location (Image Source: Google Earth, 2011)

This area was sampled five times and includes samples from both the BCMP and INAC sites (PRO 1, PRO 16, PRO 45, PRO 48, Bos 9) (Figure 24). Sampling dates range from winter (December) 2006, summer 2007, and spring, summer and fall of 2009. This region of the Creek has undergone significant changes over time from pre- to post-weir removal, including stream restoration, engineering and re-vegetation.
